New system protects USAF infrastructure

Coating spec variance secures improved performance

Location: Hurlburt Field, Eglin Air Force Base, Florida

Assets protected: Structural steel of maintenance hangar, weapons shop, and support infrastructure

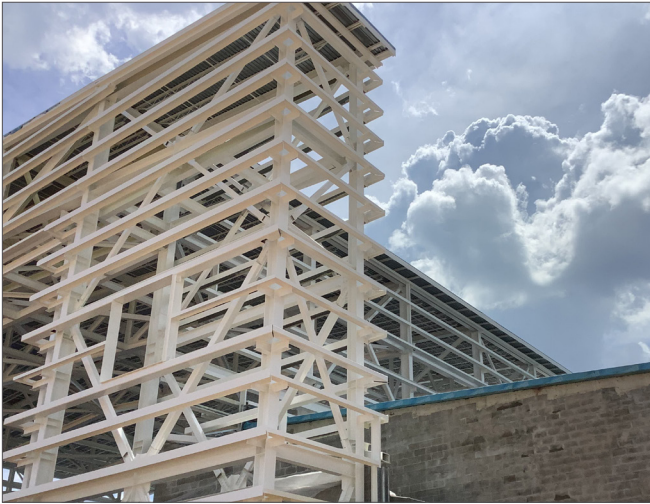
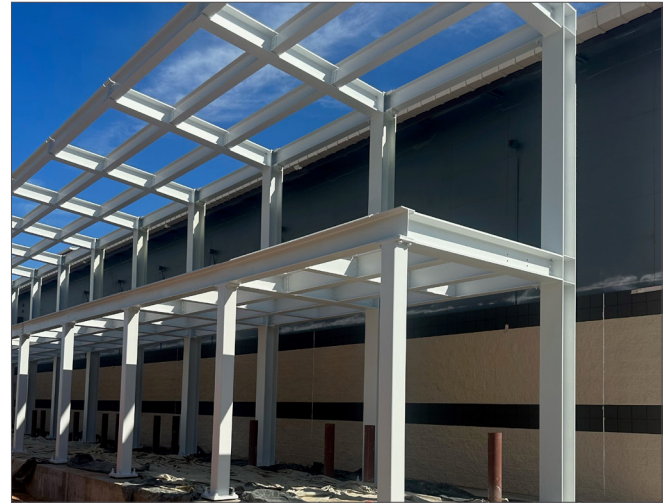
Far more of this coatings project was completed by brushing and rolling by hand than was planned. This was partly due to weather conditions including periods of strong winds. Wind contributes to the risk of foreign object debris (FOD) which must be prevented near active runways.

Initially, spray application was specified for the bulk of the work. But Champion's crews responded to volatile weather and some supply and logistics challenges by brush- and roller-applying 90% of the project.
